Scale Prevention Test Report

Product Tested: Watts Scale Prevention Media

Test Conditions: 0.5 gpm for 2 minutes every hour, 180° F

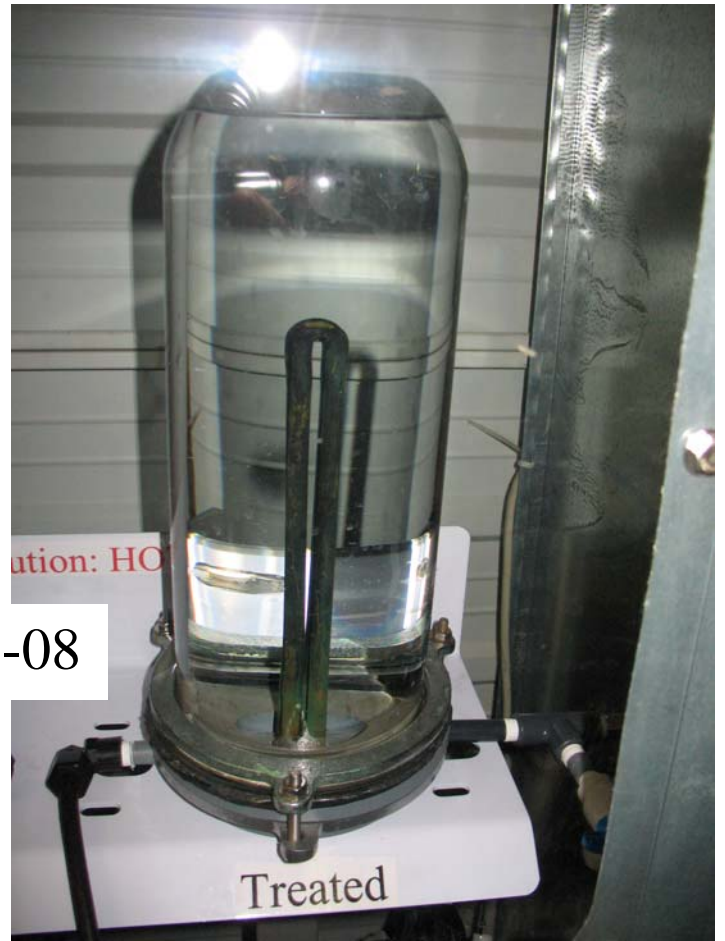
2-01-08

The tubing was changed on 2/01/08 and we began sending treated water to the scaled up chamber and untreated water to the clean chamber. The pictures below were taken three days after changing the tubing.

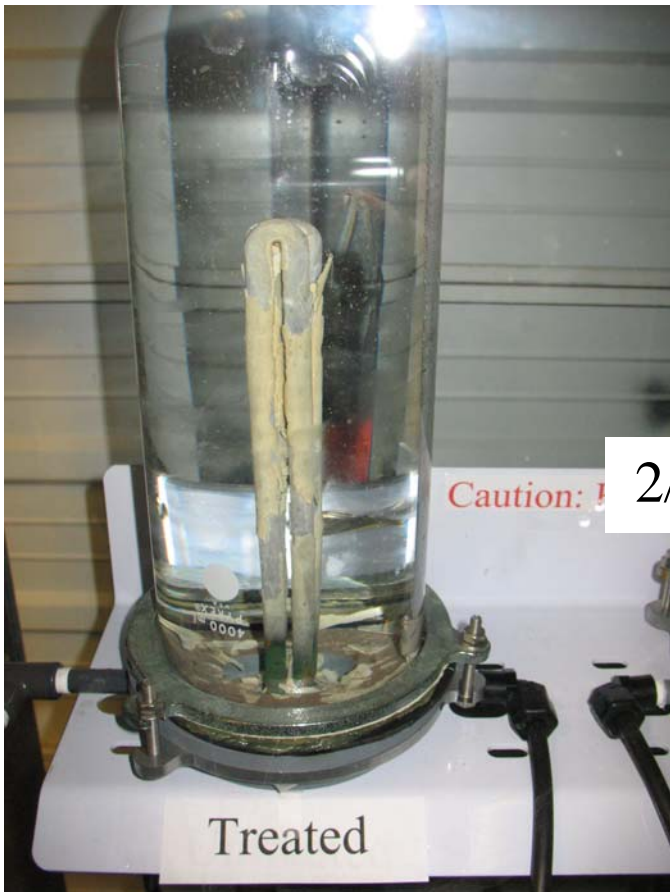
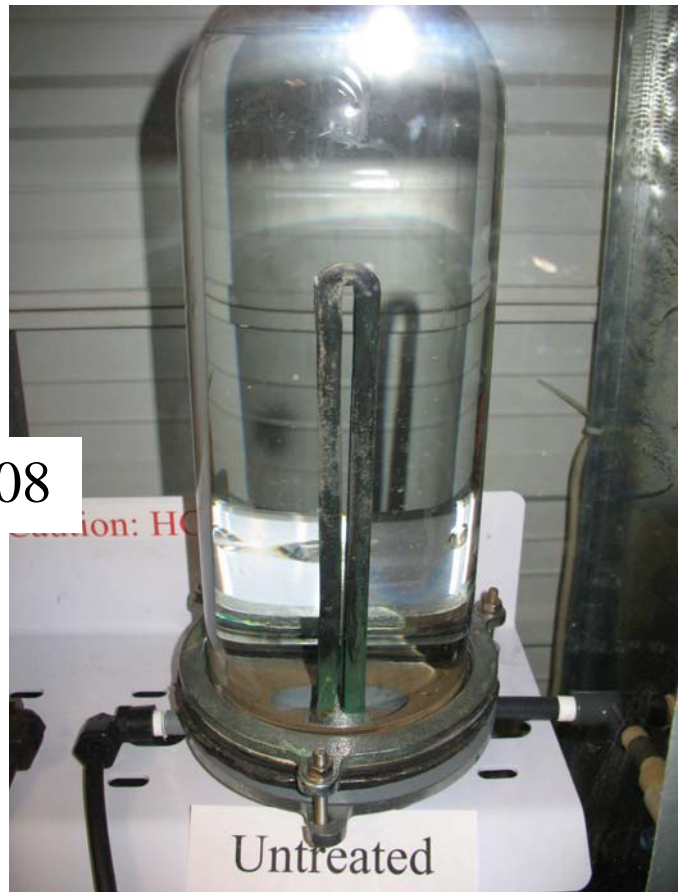
2/22/08

In the pictures below you can clearly see the de-scaling effect of the treated water on the scaled up element. You will also notice the lack of scale build up on the element that was previously fed with treated water. The element on the right has been fed with untreated water for three weeks.

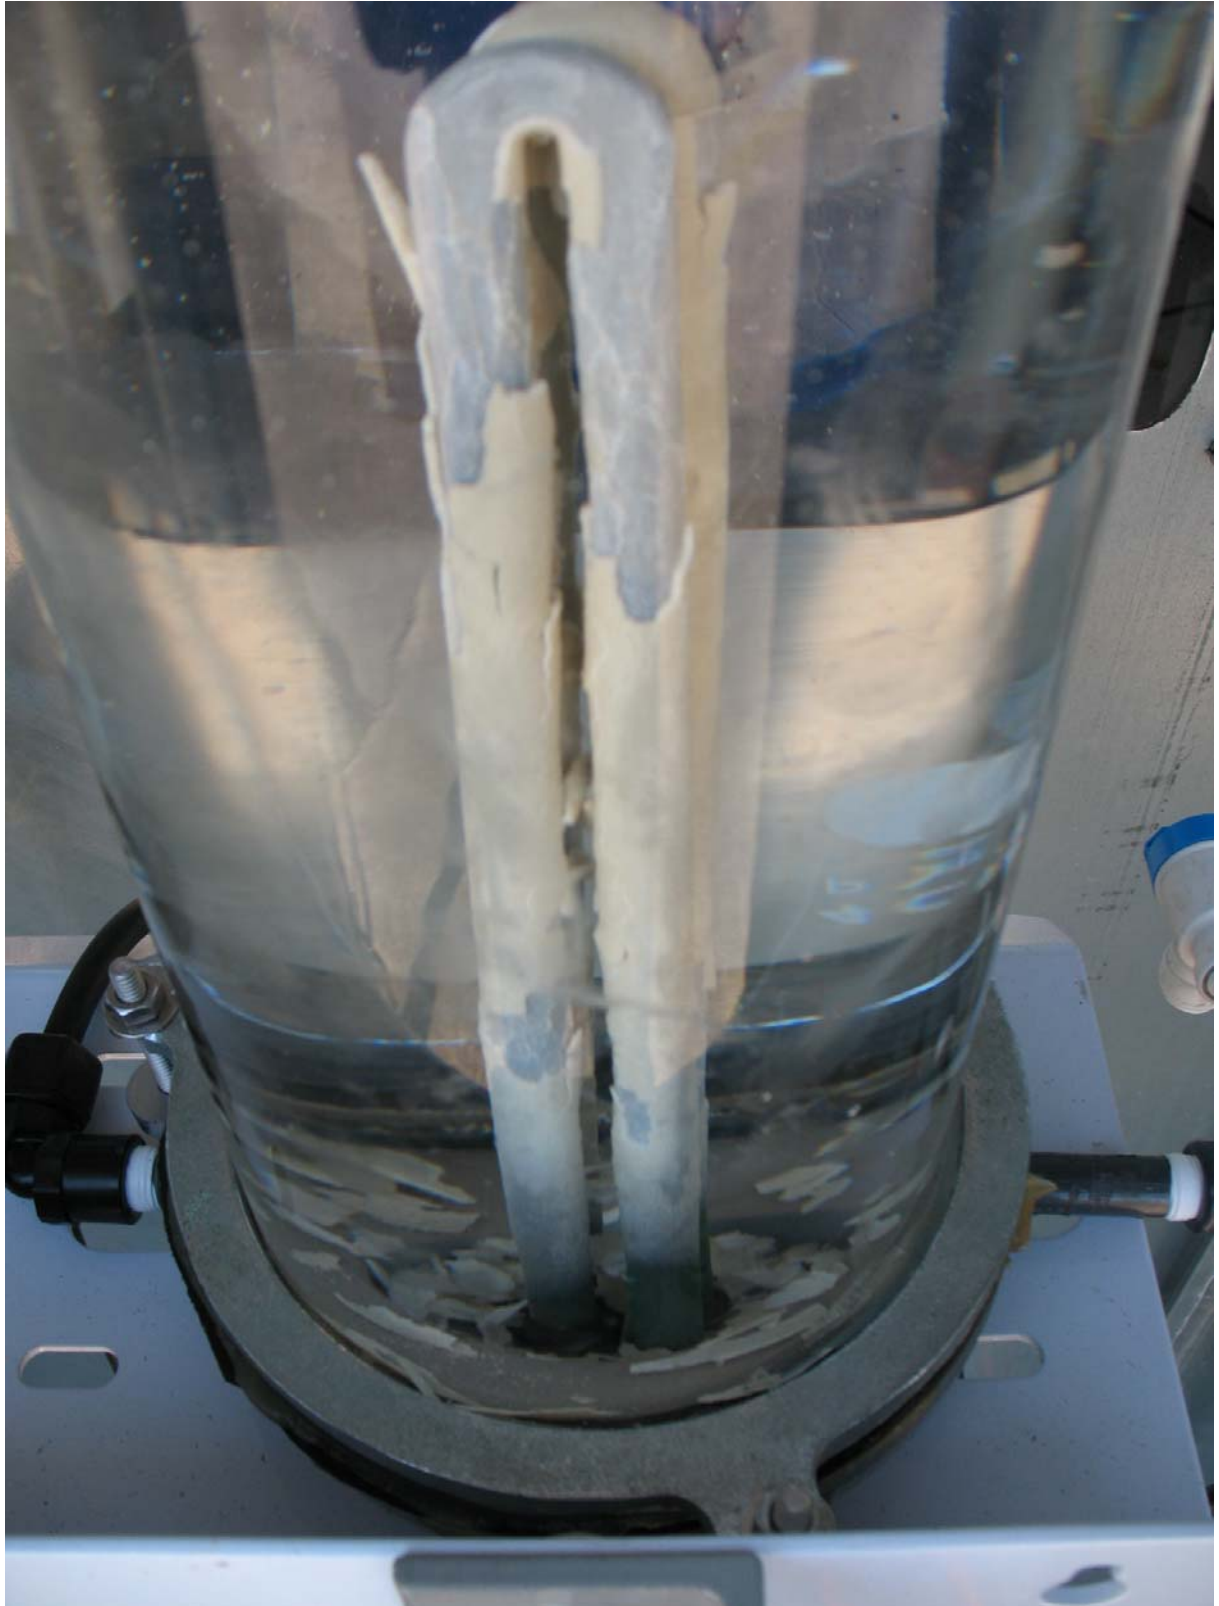
Here is a close up of the heating element that was feed untreated water for two weeks then treated water for three weeks. Notice the scale flaking off of the element. Also notice the flakes of scale on the bottom of the chamber. This picture was taken on 2/22/08.

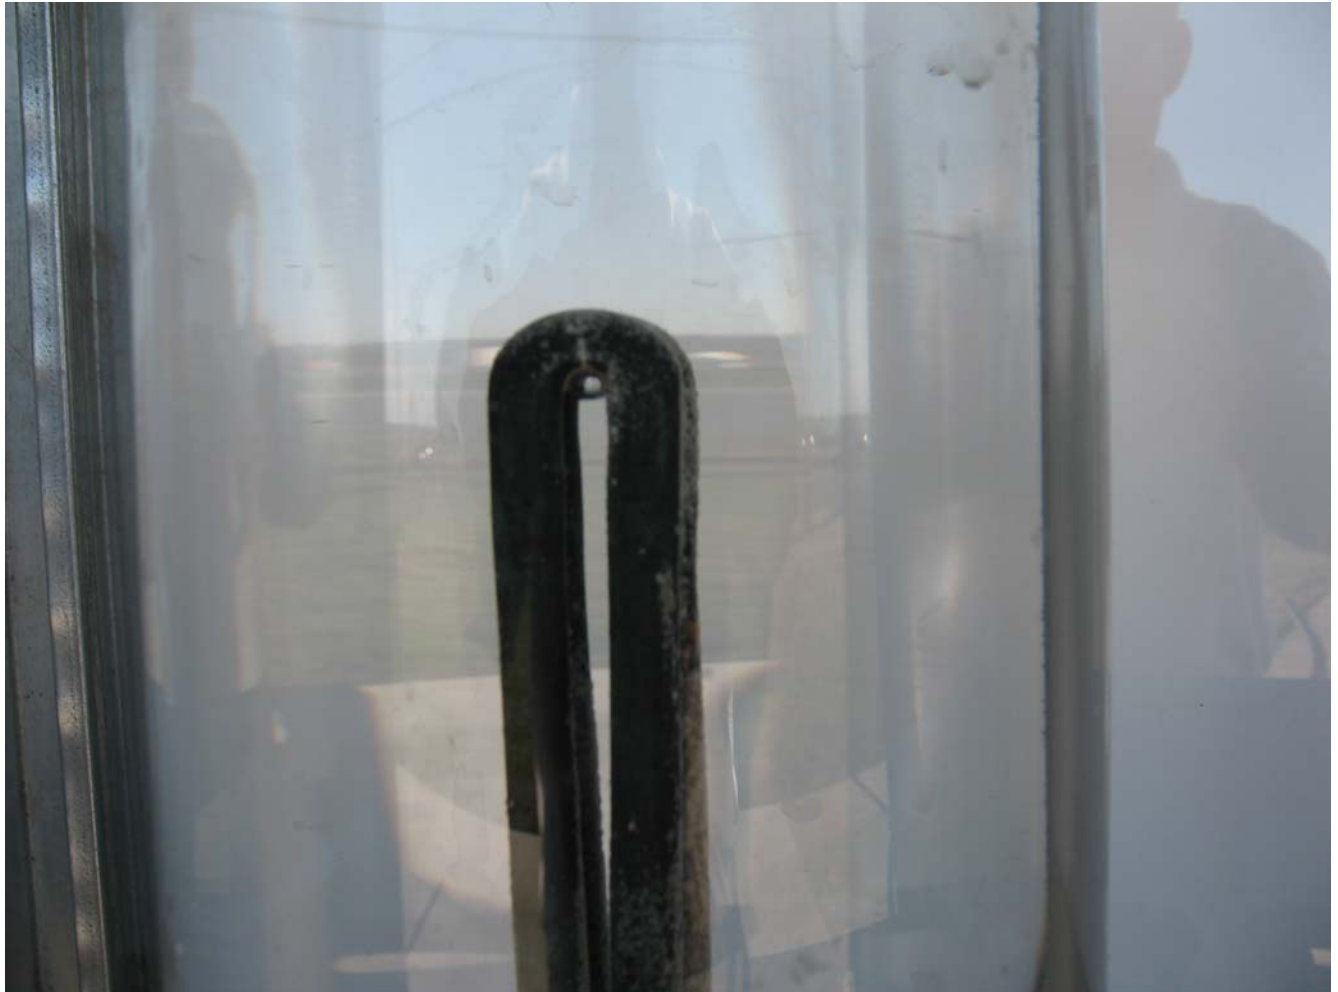
Here is a close up of the heating element that was feed treated water for two weeks then untreated water for three weeks. Notice how little scale has accumulated. This picture was taken on 2/22/08.
